### **BP Belgacom Antwerpen – Search for leakages, untight locations and water paths on reinforced concrete ceilings of inner courtyard – Moisture Scan from 2009-04-16**

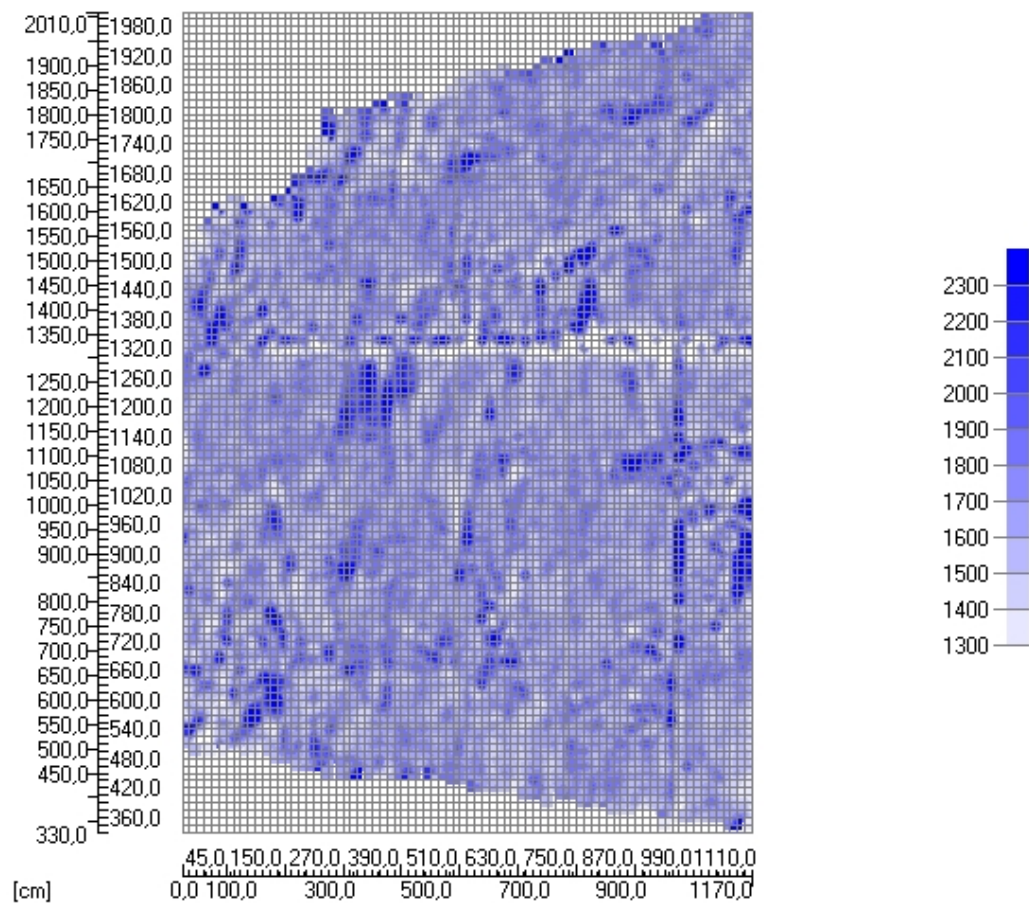
Fig. 1 FI-distribution sensor MOIST R2S – Surface

The surface scan with MOIST R2S shows some single spots with increased moisture above the sealing, but no zones that are associated to each other. Concluding there are no water paths at the surface.

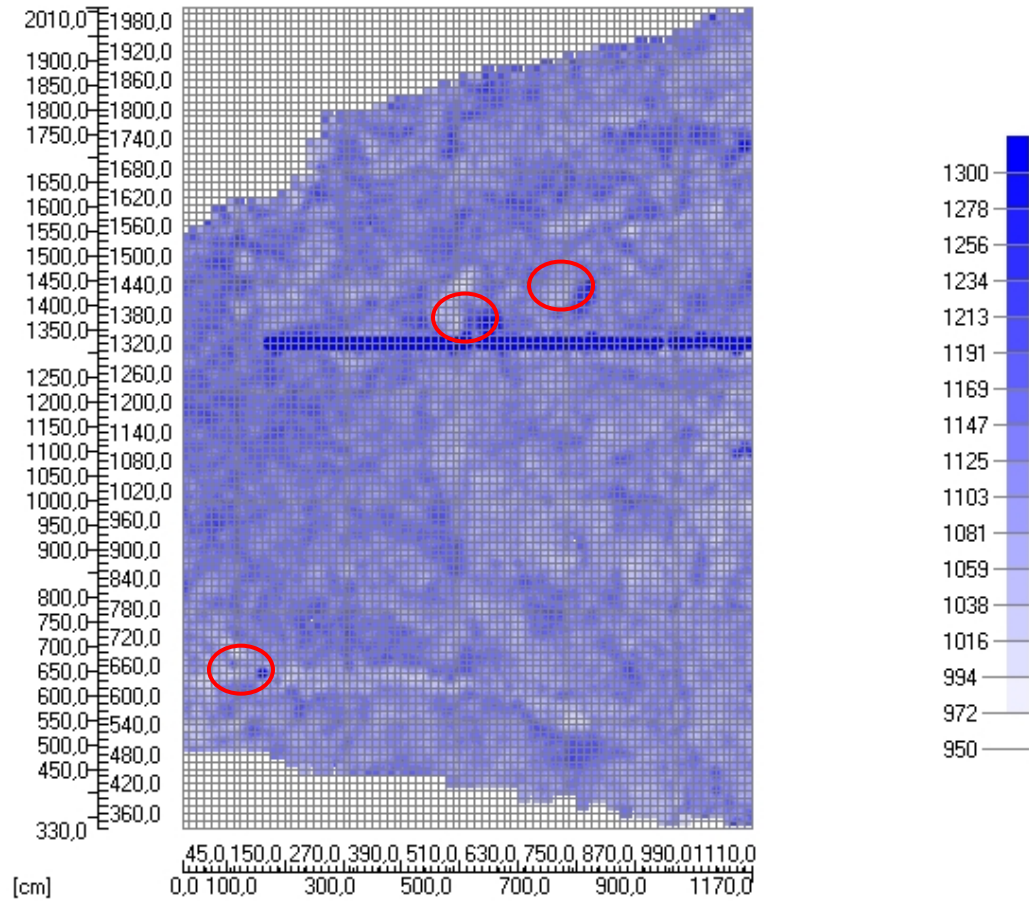
Fig. 2 FI-distribution sensor MOIST DS – Mean volume layer

The scan of mean volume layer with MOIST DS shows few striking spots in a homogeneous moisture distribution, but no moisture isles or water paths. These few striking spots are not sufficient to conclude a water damage.

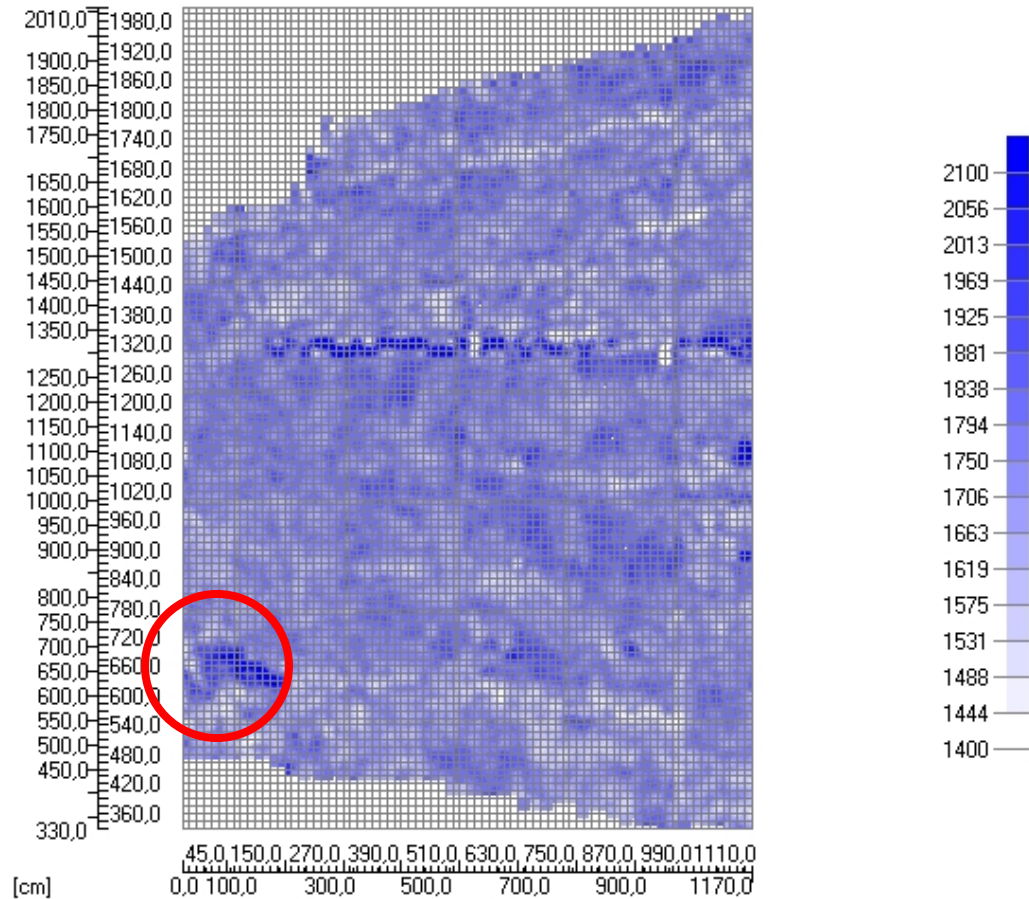
Fig. 3 FI-distribution sensor MOIST PS – Volume layer

The scan of volume layer with MOIST PS – depth region below the ceiling - shows a striking water path left had side in an else homogeneous moisture distribution. In combination with the scan in the mean depth layers this indicates a water ingress from above (wall, roof etc.) or from the side. The left side adjoins a building, so far a leakage is also possible in the area of the connection to the building.

Concluding a leakage was found in the named area at the left side with high feasibility.
