Introduction of ATP Test (Kikkoman A3) in the cleaning industry

Kikkoman Biochemifa Company
Mr. Kosuke Matsumoto

Introduction

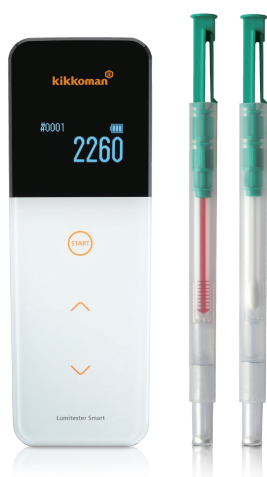
Photo 1
Left : Lumitester Smart,
Right : LuciPac A3
(for water testing and surface testing)

The biggest feature of ATP Test (Kikkoman A3) is that anyone can easily quantify “soil” in 10 seconds on site. We handle the Lumitester series as a measuring instrument for ATP Test (Kikkoman A3) and the LuciPac series as a reagent. (Photo 1)

ATP Test (Kikkoman A3) is easy and quick procedure. After swabbing the surface with a cotton swab and reagent integrated (hereafter “LuciPac A3”) and allowing the cotton swab and reagent to react, simply set it in the measurement device “Lumitester Smart” (Figure 1). Without special knowledge and skills, the cleanliness (degree of soil) can be evaluated objectively on-site, so it has been introduced in the hygiene management of various facilities.

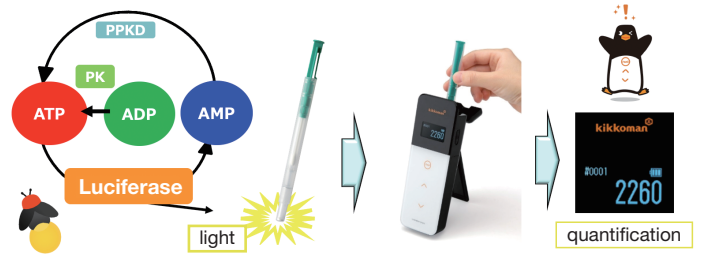
Figure 3 The principles of ATP Test (Kikkoman A3)

ATP Test (Kikkoman A3) responds to the principle of firefly light. It is used as an indicator of soil. The intensity of the emitted light is quantified (Figure 3). Generally, ATP

tests only measures ATP, but our Lumitester & LuciPac A3 measures ATP+ADP+AMP as well as ATP. When ATP is decomposed by heat/fermentation, it becomes ADP (adenosine diphosphate) and AMP (adenosine monophosphate). Our LuciPac A3 can measure ATP+ADP+AMP by using proprietary techniques that return AMP and ADP to ATP. This allows for more rigorous hygiene testing compared to testing using only ATP as an indicator. The test method that measures the “ATP+ADP+AMP” at the same time is called the “A3 method” (Figure 3).

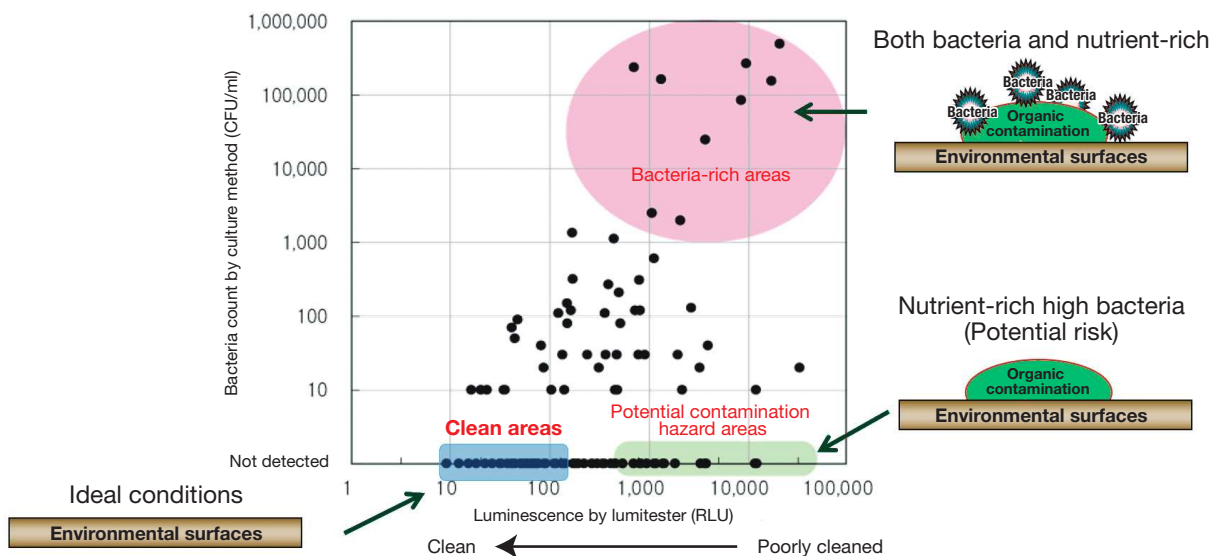
Figure 4 Relation between light emission (RLU) and bacterial count (CFU)

Figure 4 shows the results of simultaneous ATP Test (Kikkoman A3) and microbiological tests (culture method) in a large-scale cooking facility. The vertical axis indicates the number of bacteria, and the horizontal axis indicates RLU count*. In the upper-right pink area, both the bacterial count and RLU level are higher. For food facilities, "high RLU value" = "high food residues" meaning nutrient that bacteria tends to grow on still remains. This will lead to high risk of foodborne illness.

On the other hand, the green part at the lower right has a low bacterial count but a high RLU. In this case, food residues

are considered to be high, so secondary contamination of bacteria (cross-contamination) later may increase the risk of foodborne illness. You should be aware of potential risks.

Ideally, this should be maintained in the light blue area in the lower left corner (low bacterial count and low RLU level). The risk of foodborne illness is considered to be very low because the bacteria are removed and the residues that are the nutrient source of the bacteria are removed.

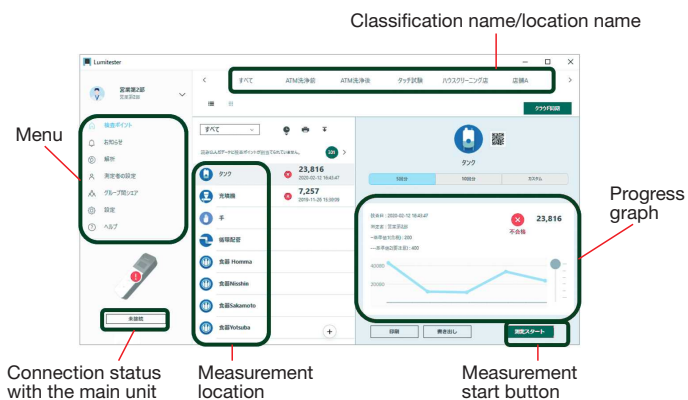
Figure 5
Screen image of Lumitester App (screen for PC and tablets)

The Lumitester Smart is a device that quantifies “cleanliness” on-site. Data collected at the site can be effectively used as digital data even after leaving the site. For example, by downloading dedicated apps (hereinafter referred to as “Lumitester App”, Figure 5) to devices such as tablets, smart phones, and personal computers, data can be linked by Bluetooth or data can be stored in the cloud.

It is easy to share the results obtained at multiple sites, and to analyze various types of data such as graphs. Users of the Lumitester App also highly praised the fact that the measurement time is automatically recorded, that it is unnecessary to transcribe the site records, and that it is possible to prevent tampering.

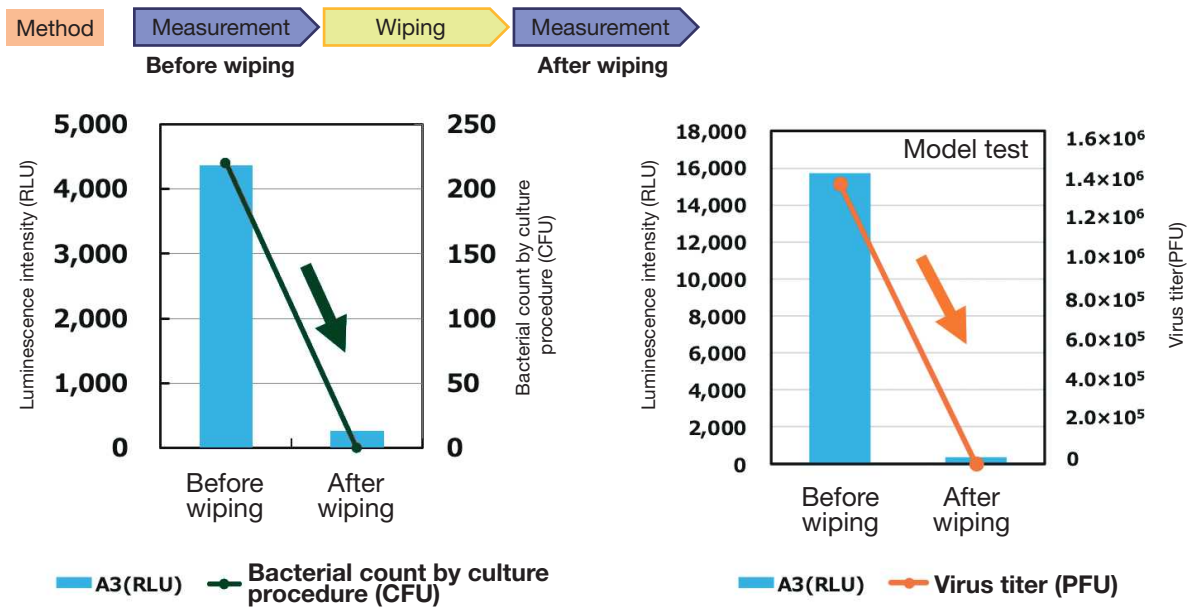
Figure 7 Effect of cloth cleaning Model test

ATP Test (Kikkoman A3) and a culture test for microbes and viruses were performed before and after cleaning with microfiber cloth (Tolecy), and the effectiveness of the cleaning was investigated. The results are shown in Figure 7. ATP Test (Kikkoman A3) and the number of viable bacteria were examined before and after the cleaning process at the desk of a hospital. To the right, simulated saliva including ATP and feline calicivirus were applied to the plastic. ATP Test (Kikkoman A3) and virus titer were measured before and after cleaning. It was confirmed that RLU levels, total viable cell counts,

and viral titers were significantly decreased by wiping.

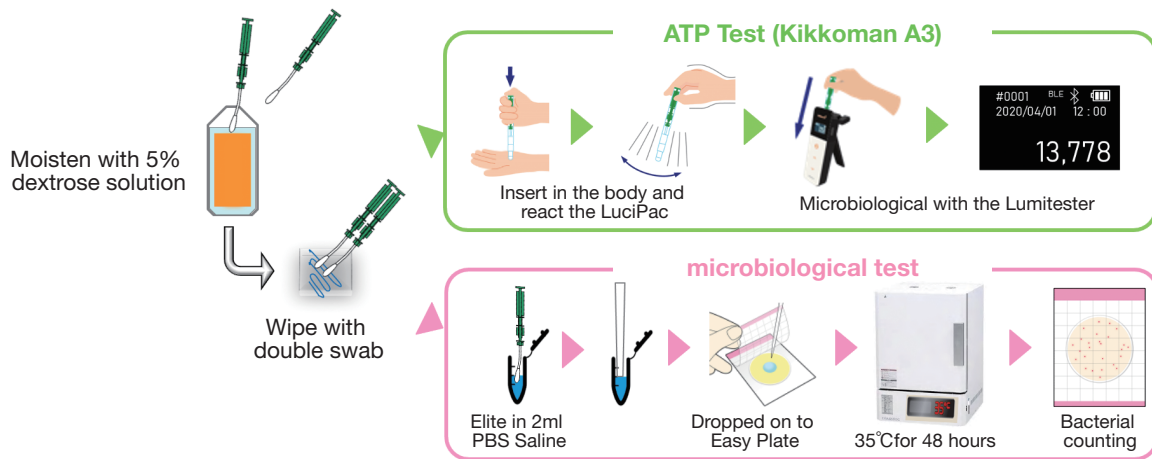
Figure 8 ATP Test (Kikkoman A3) and microbiological test in office buildings

In concrete terms, we will introduce how ATP Test (Kikkoman A3) can be performed in office buildings. Swab the same area with two cotton swabs at 24 locations in a certain building (reception area, elevators, offices, toilets, etc.), and wipe one side with ATP Test (Kikkoman A3) and

the other was tested for bacteria.

Measurements were performed prior to and after cleaning using Tolecy and Easy Plate AC (manufactured by Kikkoman Biochemifa.Co., Ltd) was used for bacterial testing (Figure 8).

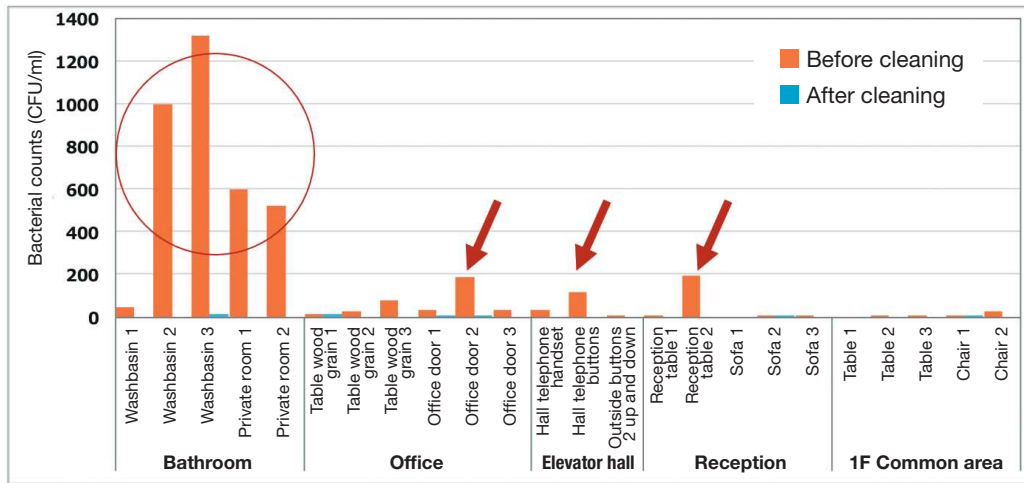
Figure 10 Changes in the number of viable bacteria before and after cleaning

As for the results of the bacterial test, the measured values of the toilet washstand and door were slightly higher before cleaning, and a certain number of bacteria was found on the office door, telephone button, and reception table, but other than that, the number of bacteria is small (Figure 10). After

cleaning, everything is less than 20 CFU and daily cleaning is carried out.

The low bacteria count was also due to the fact that the number of users was lower than usual during the period.

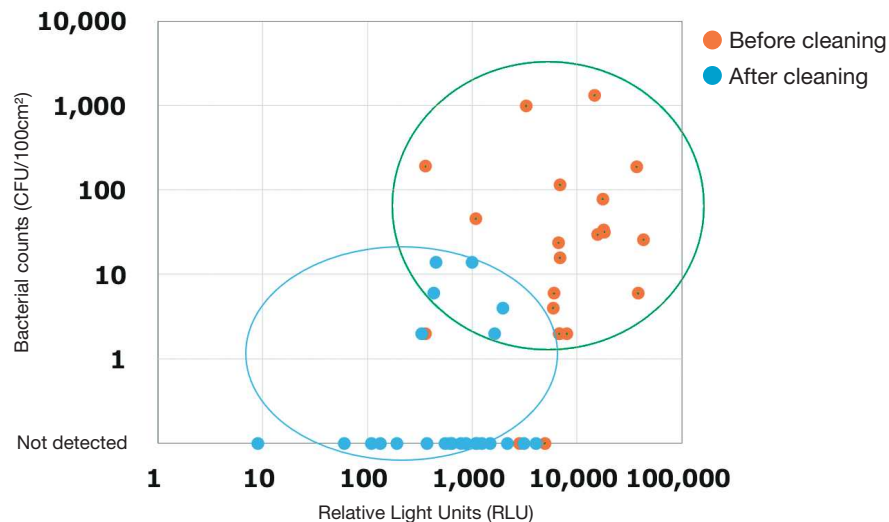
Figure 11 ATP Test (Kikkoman A3) and bacterial test before and after cleaning

Figure 11 shows the changes in ATP Test (Kikkoman A3) and bacterial test before and after cleaning. The plot distributed in the upper right (orange color) before cleaning is

moved to the lower left (light blue color) after cleaning.

It was confirmed that both the bacterial count and RLU level were clearly low.

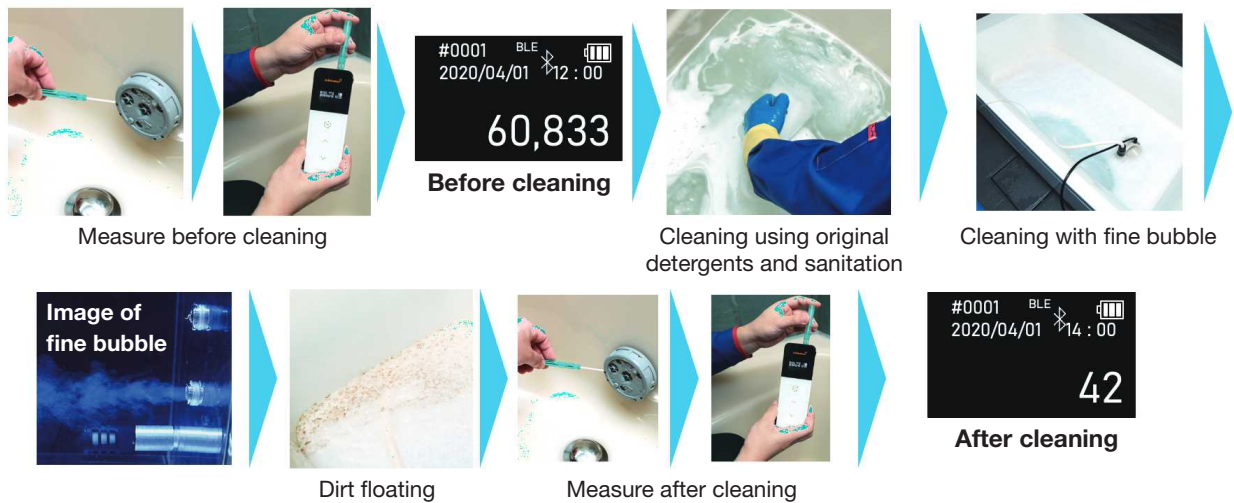
Photo 2 : Example of using ATP Test (Kikkoman A3) in the cleaning service business

Osoji Honpo (HITOWA Life Partner Co., Ltd.) uses ATP Test (Kikkoman A3) to clean the reheating piping of bath rooms and drum-type washing machines. Implementation of ATP Test (Kikkoman A3) before and after cleaning clearly conveys the effectiveness of cleaning. (Photo 2)

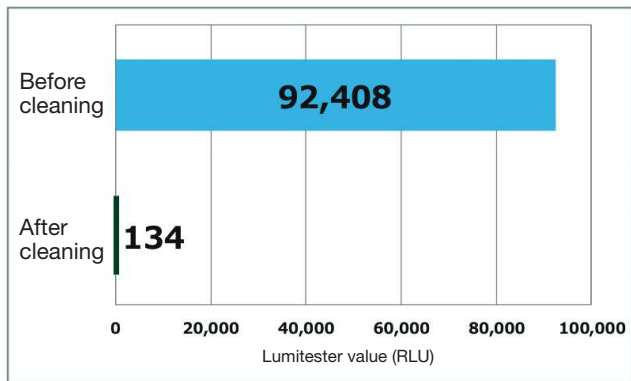
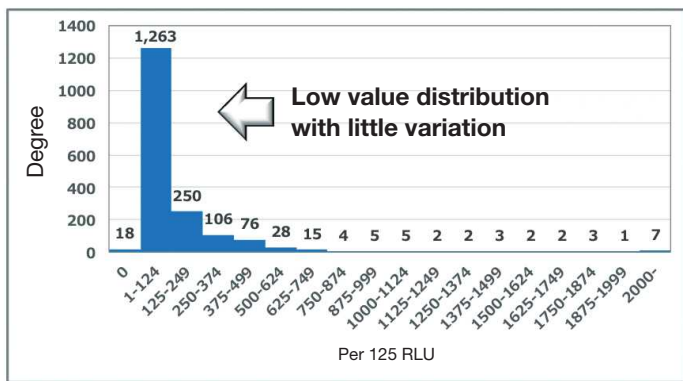
Figure 12 Changes in the measured value (RLU value) of ATP Test (Kikkoman A3) before and after cleaning the reheating piping in the bathroom

As an example of a pass/fail limit, the pipe inlet has a rule of “re-clean when 500 RLU is exceeded”.

For a period of time (n=1793), the mean of before cleaning was 92,408 RLU, but after cleaning it was significantly improved to 134 RLU (left-hand in Figure 12). In addition, looking at the distribution after cleaning (to the right in Figure 12), we found that there was little variation in RLU values. 90 percentile was 342 RLU, and we were able to confirm that the standard value of 500 RLU was appropriate.

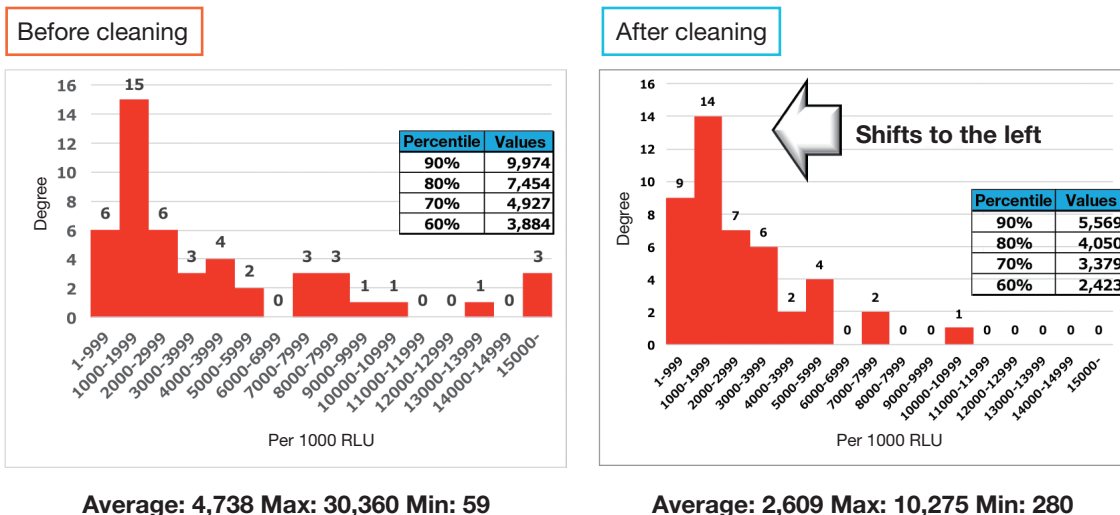
Figure 13 Changes in RLU before and after cleaning at hotels

One hotel worked with Kao Professional Services to improve guest room cleaning and enhance the quality of cleaning to ensure that guests can use the hotel with safely. ATP Test (Kikkoman A3) was conducted at 45 locations in the guest rooms. There were 20 locations that passed the test (light blue on the table), 6 locations that required caution (yellow on the table), and 19 locations that failed the test (pink on the table) (Pass: below 2,000 RLU, Fail: 3,000 RLU). We also found

that RLU after cleaning was generally low (Figure 13).

Based on these results, we are working to improve the cleaning specifications and improve the quality of the cleaning. For example, ATP Test (Kikkoman A3) was added to the areas requiring special attention (e.g. shoehorns and hangers) and the “failed” areas as the new areas where ATP Test (Kikkoman A3) is performed after cleaning. We are also working to establish new cleaning specifications that take hygiene measures into consideration.
